623 Monument Street (House)
Danville
Pittsylvania County
Virginia

HABS No. VA-1036

ARCHITECTURAL DATA FORM

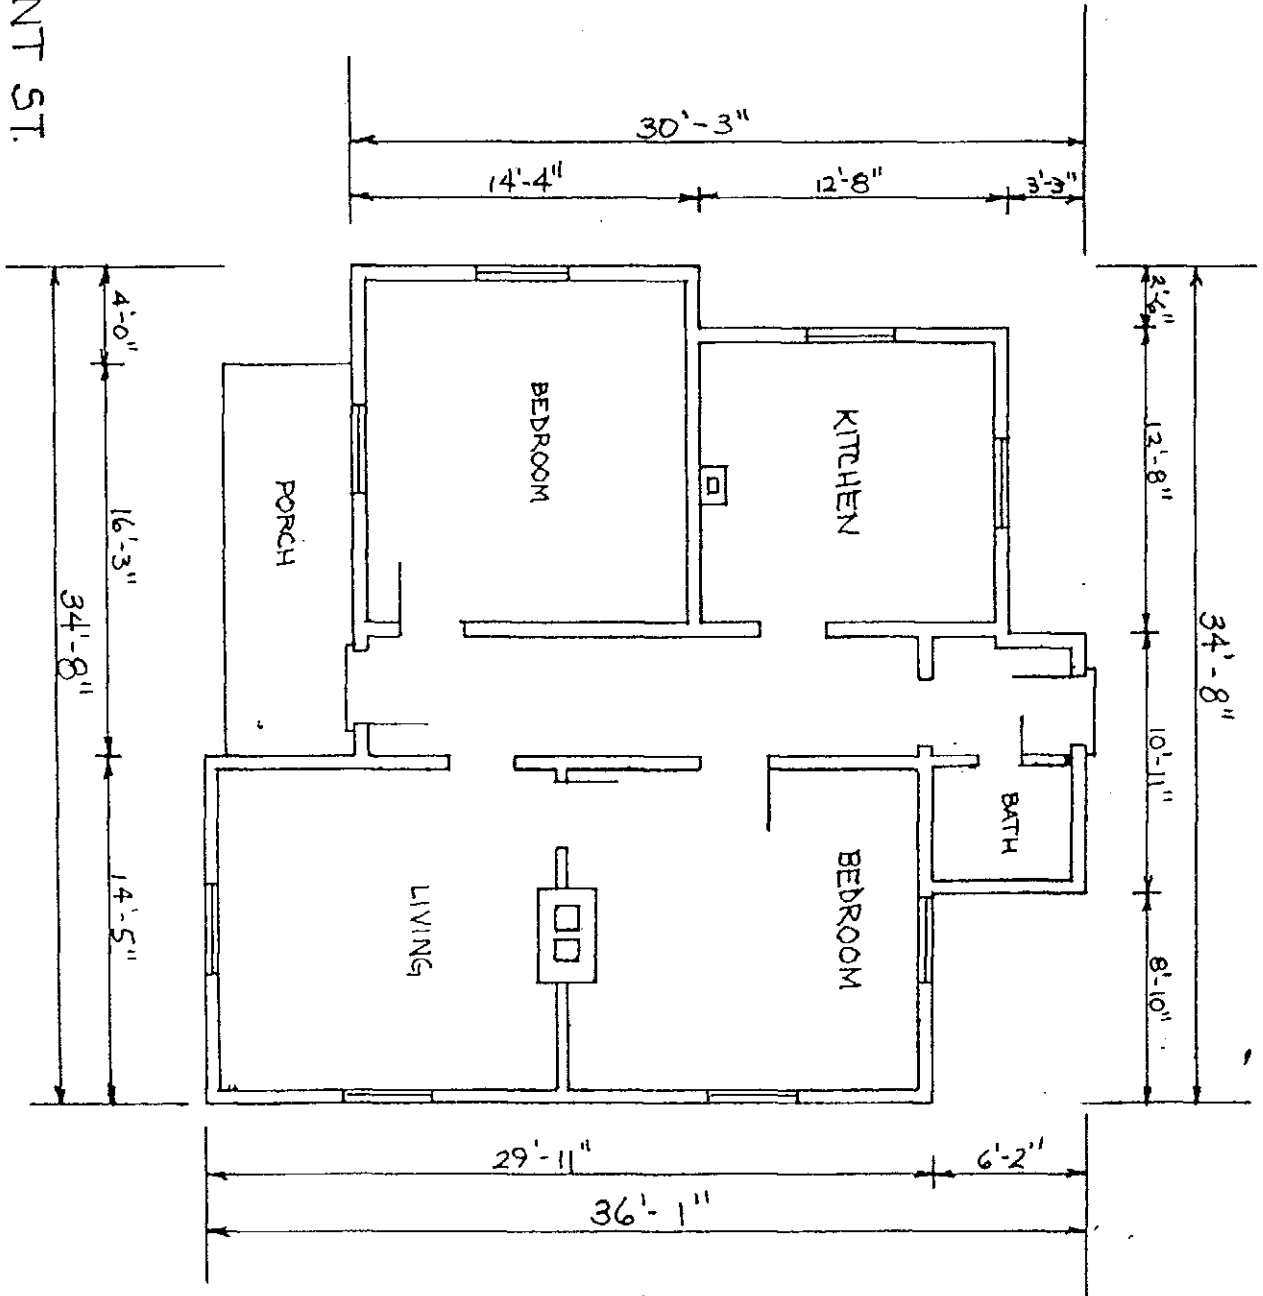
623 MONUMENT ST.

EXTERIOR FEATURES OF NOTE Clapboard construction; two-over-two-light window sash; pierced gable ventilators; tern roof.		
INTERIOR FEATURES OF NOTE (DESCRIBE FLOOR PLANS, IF NOT SKETCHED) Central hall plan; two rooms on each side; bath added at rear of house.		
MAJOR ALTERATIONS AND ADDITIONS WITH DATES Back porch and bath added; date unknown.		
PRESENT CONDITION AND USE The house was in poor condition and was used as rental property for several decades, until its purchase in March 1985. Deterioration including foundation, interior walls and ceilings, floors, eaves, exterior wood surfaces, porch, rear stairs, etc.		
OTHER INFORMATION AS APPROPRIATE Copies of documentation will remain on record in archives of the National Tobacco-Textile Museum.		
SOURCES OF INFORMATION (INCLUDING LISTING ON NATIONAL REGISTER, STATE REGISTERS, ETC.) 1894 Sanborn Insurance Map Tax List, City of Danville Real Estate Assessor's Office 1898-99 City Directory 1960 Factory Insurance Assoc. Tob-Text Mus. Archives 1978 HAER Danville Whse. Dst. Inventory 1899 Sanborn Insurance Map, Tob-Text Museum Archives

SCALE $\frac{1}{8}" = 1'-0"$
